Ebrie Burn - Mill of Elrick

Walkover Survey Assessing Abstraction and Fish Passage Concerns on behalf of the Ythan DSFB

20/08/2024

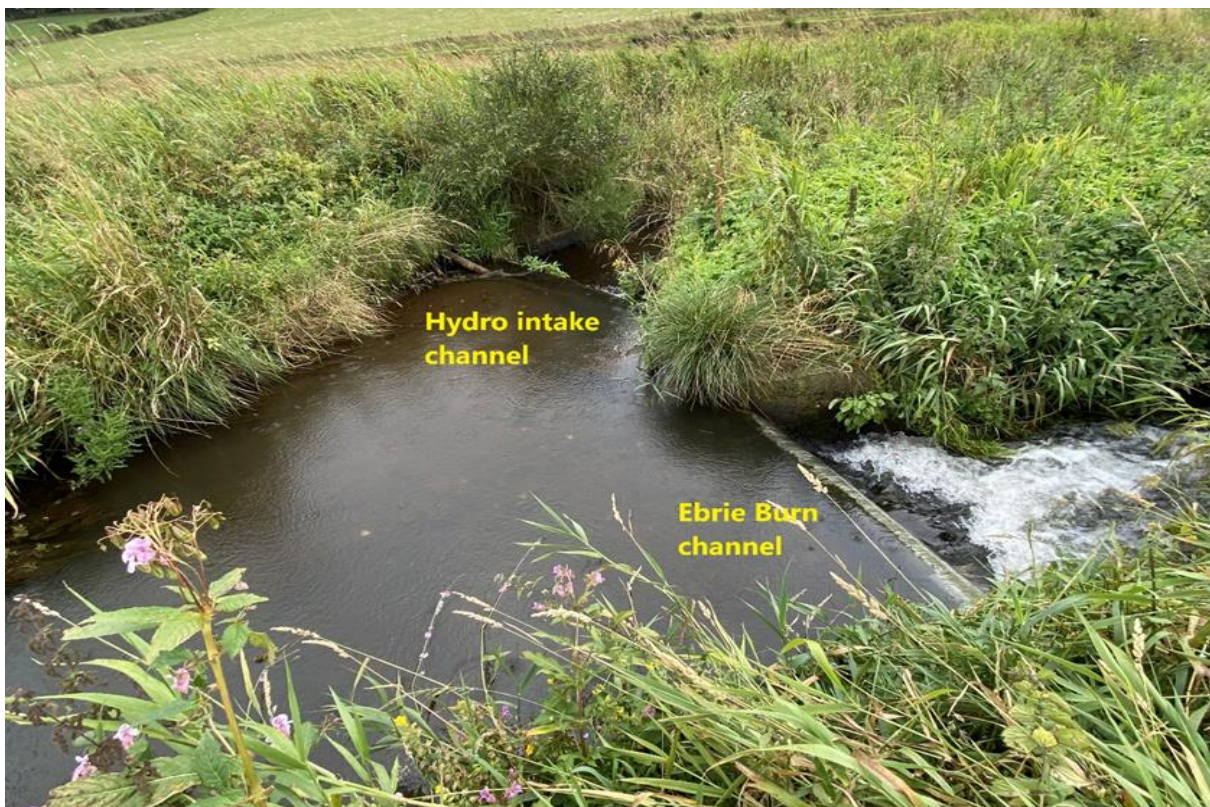
The right channel feeds the depleted section of the Ebrie burn, and the left channel feeds the abstraction intake, for the now defunct Mill of Elrick Fishery and Hydro Scheme. Figure 1 below showing the two channels in question.

Fig 1. Denoted channels on the Ebrie burn at Mill of Elrick water abstraction site.

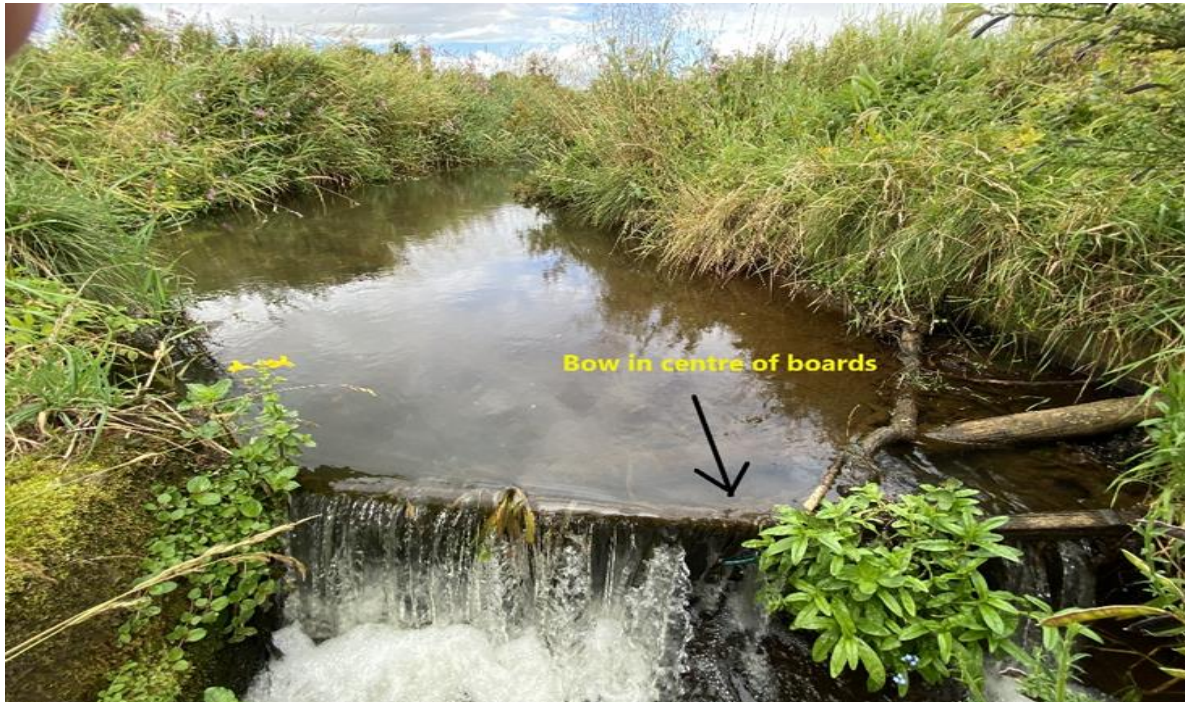
The intake structure is poorly designed and has inadequate controls over the flows being abstracted. At the top of the Hydro intake channel there are two thin wooden boards which have been placed to check the flow. Pressure from behind the boards has caused a noticeable bow in the centre, the boards also show signs of decay and are at risk of failing. If these boards were to breach, it will result in most of the water being drawn into the abstraction channel, leaving very little flow if any down the depleted channel of the Ebrie burn. This would be devastating for the fish and invertebrates in the depleted Ebrie Burn. See figures 2 & 3 below of the two boards in question.

Fig 2, above showing bow in centre of boards at top of abstraction channel

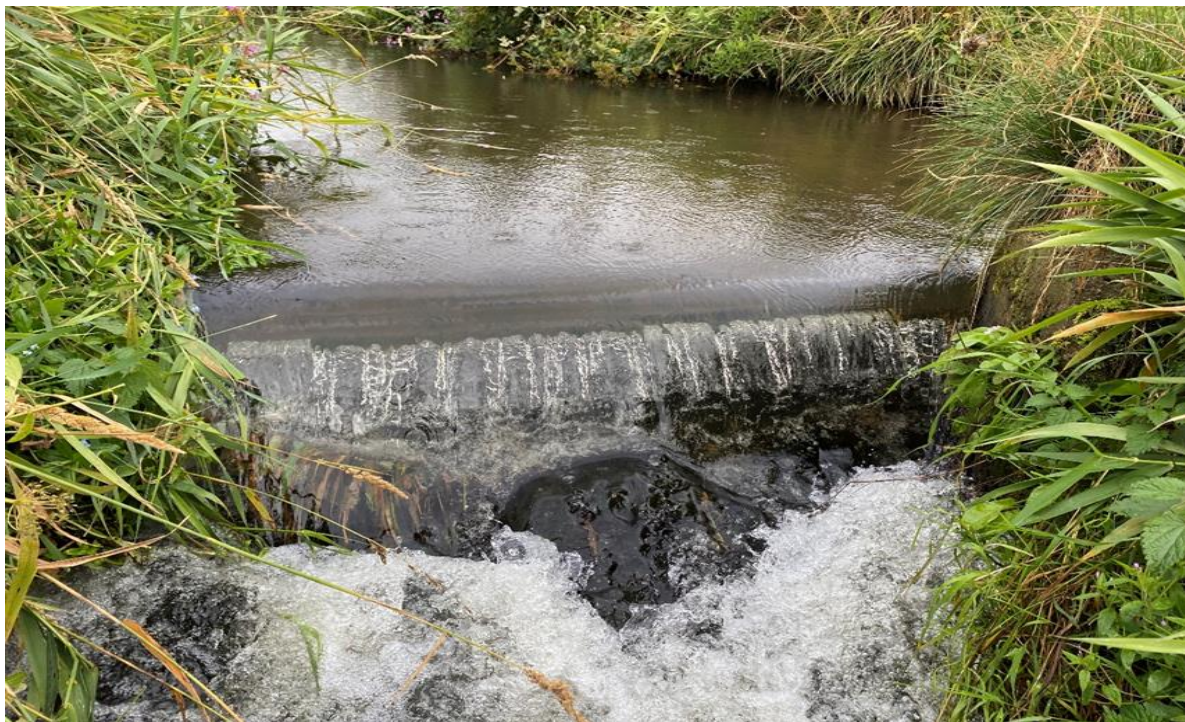
On the Ebrie channel there are also wooden boards that have been placed, these boards have no notch in the centre to allow fish to freely ascend over this obstruction.

Fig 3. Below showing boards placed at the top of the Ebrie burn channel causing obstruction.

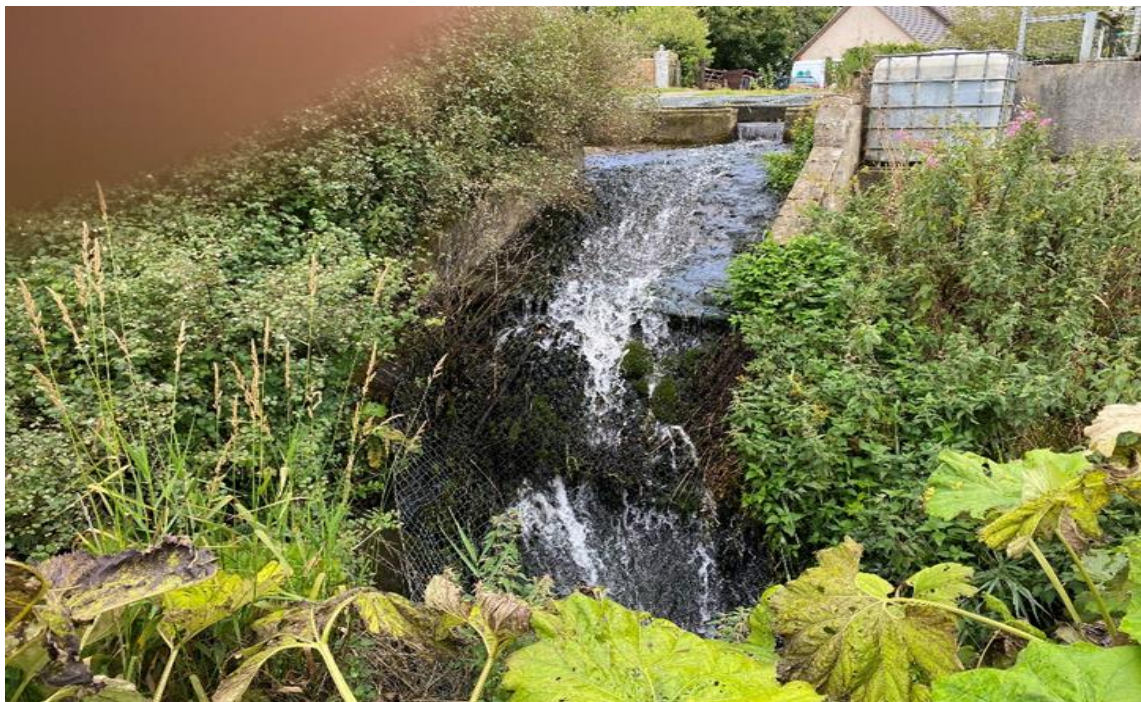
Fig 4, Spillway from hydro scheme.

Approximately 900m further downstream is a spillway where water exits from the hydro scheme lade. This is a very steep decline with rocks at the bottom and wire mesh on the face. Salmon and sea trout smolts migrating downstream through the hydro scheme lade, have to exit over this spillway which could possibly cause serious injury, entrapment or death, figure 4.
