2. Habitat walk over survey undertaken September 2023.

An assessment of potential restoration options was made during a habitat walkover survey on the Ebrie Burn on the 27th of September 2023 between the reach of Glenebrie Bridge Grid Ref NJ93480/39920 down to Drumwhindle Bridge NJ93310/35830

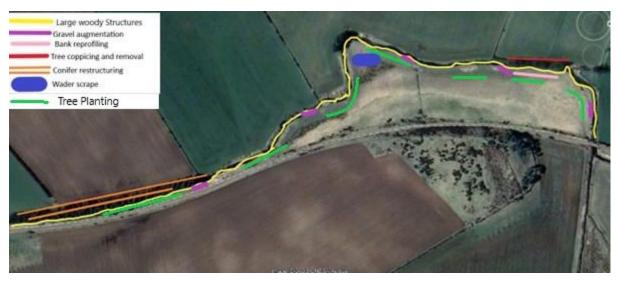
Section 1, NJ 99320/39760 to NJ 93455/39045. Length 1km, burn flows right to left.

Chosen section below for habitat improvement opportunity, Grid Reference NJ93320/39760 down to NJ93245/38290. Combined length of both sections measuring 1.70 kilometres or (1.05) miles.

Restoration Options.

- Possibly up to 9 LWS installed to create further cover plant required to install.
- Coppice and remove individual trees to reduce tunnelling effect, which will allow light into the stream.

- Planting of native broadleaved trees in pockets using biodegradable tubes with stakes, along approx. 1km of riverbank on this section, this would provide essential dappled shade reducing water temperatures, provide nutrients, stabilise riverbanks and eventually create natural large wood structures.

- Clear non-native conifers 20m back from river edge to conform with (FLS guidelines), Hand fell trees 5m or so from the stream embankment, trees further back from riverbank can be knocked over with plant to retain root plates for use as in-river LWS.

- Reprofile streambank to a lesser grade to prevent further erosion from occurring.
- Gravel augmentation, to enhance spawning.
- Creation of wader scrapes, to enhance different types of invertebrates, vegetation, and wading bird species.

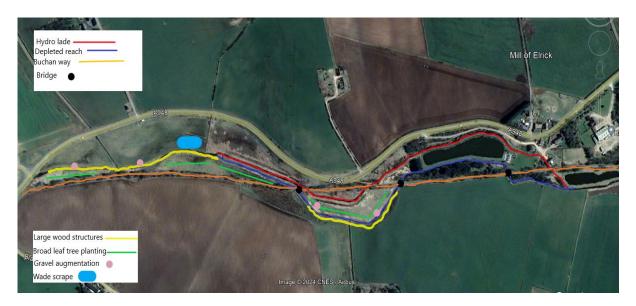
Section 3, Auchnagatt Bridge NJ 93255/41650 to NJ 93550/40350. Survey length 1.5km, burn flows right to left.

This survey area of the Ebrie burn, commencing from Auchnagatt bridge downstream to a length of 1.5km. It is a very complex section with a hydro lade, depleted reach of the Ebrie burn, three bridges in proximity and the Formartine and Buchan pathway runs directly through the section. I have identified two areas for habitat restoration proposal, which you can see in the map above in yellow. The top section measures 400ms and further downstream is another small area measuring 300m. Restoration options below.

Restoration Options.

- Possibly up to 4 LWS installed to create further cover plant required to install.
- Planting of native broadleaved trees in pockets using biodegradable tubes with stakes, along 2 sections chosen.
- Gravel augmentation, to enhance spawning.
- Creation of wader scrapes, to enhance different types of invertebrates, vegetation, and wading bird species.
- Buffer zone to be created for tree planting.
