YTHAN DSFB HABITAT IMPROVEMENT PLAN 2026

Draft for Approval

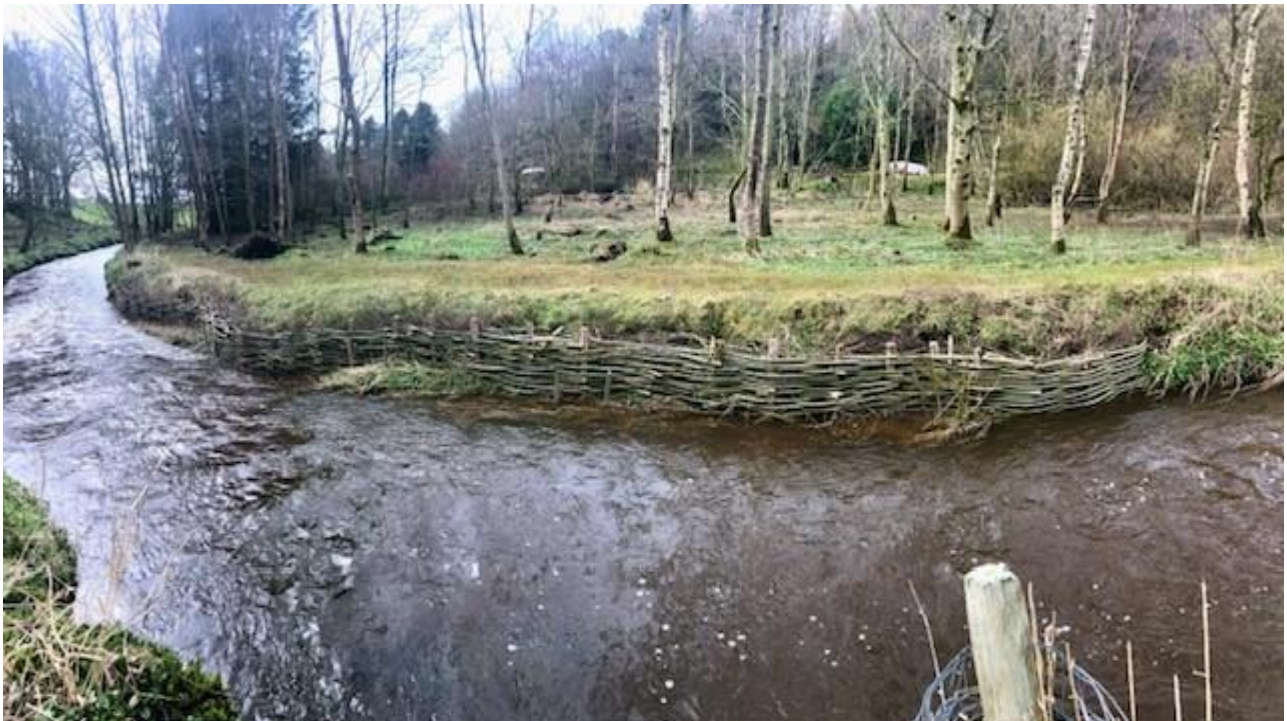
Ebrie Willow Bank Repair April 2022.

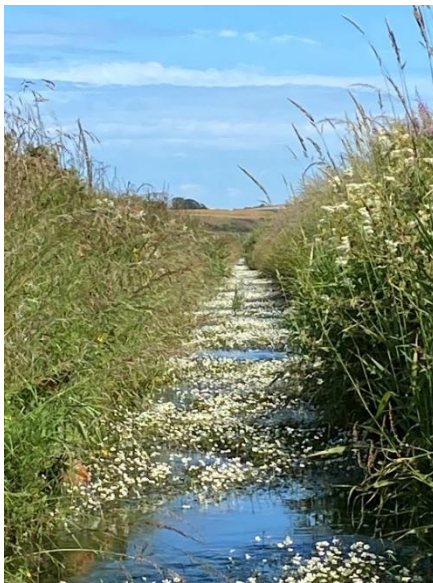
Fig, 1 before weed cutting.

Targeted removal of the aquatic weed Ranunculus can enhance spawning habitats by preventing fine sediment accumulation. In 2025, 3 Tributaries were targeted for Ranunculus weed cutting. The Ebrie burn, Burn of Fortree which is a tributary of the Ebrie burn and 1 section in the middle reaches of the Fourdon burn. 10 sites were chosen over a 10km stretch of the Ebrie, from Glenebrie bridge downstream to Drumwhindle bridge. On the Burn of Fortree, a 473-meter section was sympathetically cut, still leaving fish cover for protection and good feeding from aquatic invertebrates. On the Fourdon burn, 1 section in the middle catchment was cleared, which will allow salmon and trout to access weed free spawning substrate.

Figure 1 and 2 below illustrating before cutting and after the weed was cleared from the section.

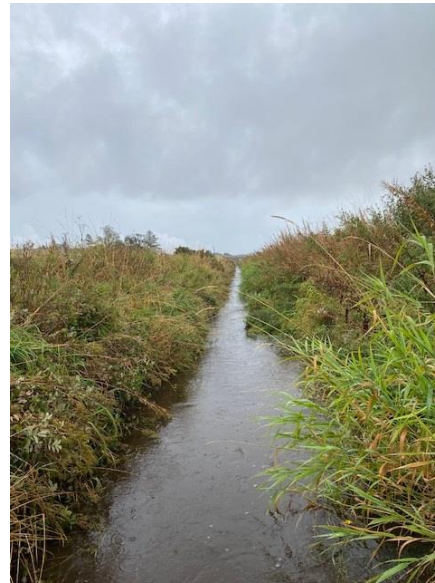
Fig, 2 After weed cutting.

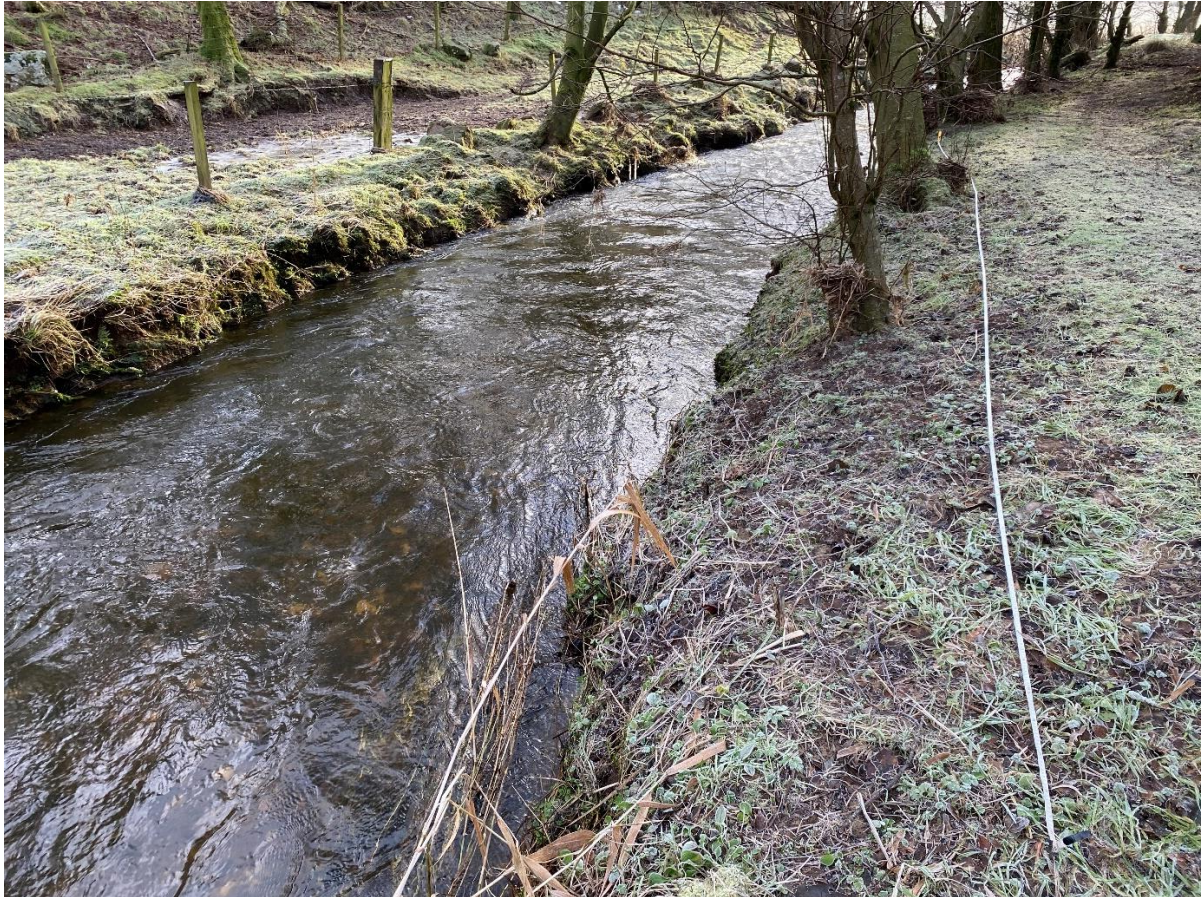
Fig 3, Below site 1 Ebrie burn, 12 meters in length.

For the 2026 habitat improvement plan, I have chosen 2 sites for Gravel washing, both of these are on the Ebrie burn and are around 20 meters apart. Gravel washing has not been carried out on the Ebrie since 2021. During Redd counting surveys, it was very evident how compact the spawning substrate had become. This is simply due to the amount of fine sediment that moves through the Ebrie system at certain times, especially after long periods of dry weather, then as sediment accumulates it is then flushed into the streams during very wet spells, colouring the water very quickly. I have spoken to the owners who own that section of the Ebrie gravel washing site, and they have given permission, if it's approved by the Ythan DSFB to carry out this task.

River/Tributary	Grid Reference	Activity	Time Scale	Description of Activity
Ebrie burn Site length 12 meters	Site 1, NJ 93608/40119	Gravel Washing	4 Days	Apply for SEPA engineering simple licence. Set sediment net below site, loosen gravel with hand tools to free sediment. Use leaf blower to further free sediment, rake gravel level over site.
Ebrie burn Site length 8 Meters	Site 2, NJ 93561/40039	Gravel washing	2 Days	Apply for SEPA engineering simple licence. Set sediment net below site, loosen gravel with hand tools to free sediment. Use leaf blower to further free sediment, rake gravel level over site.

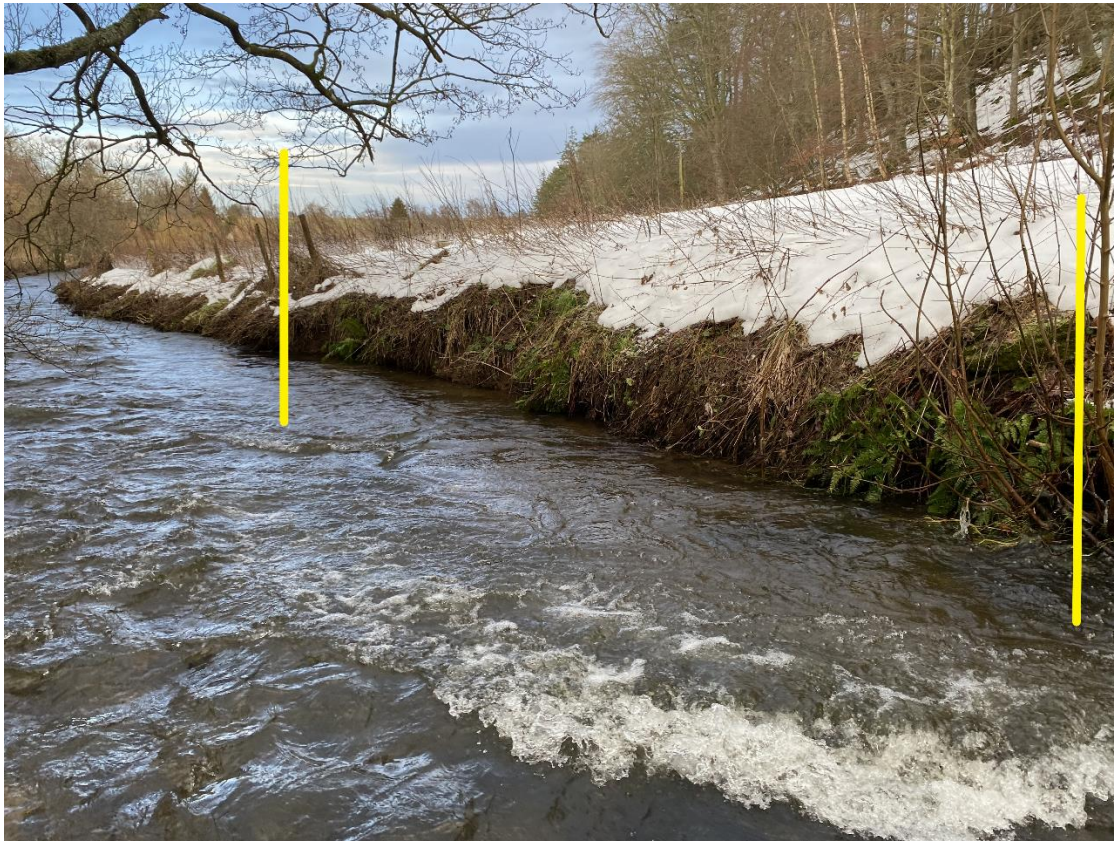
Fig 4, Below Fourdon burn bank erosion site, between the yellow lines.

Fourdon Burn is an excellent spawning tributary of the river Ythan and when appropriate water levels are available in the river, the salmon frequently migrate up this stream to spawn. Over recent years there has been some very large floods that have caused bank erosion at one key spawning area on the Fourdon burn. The burn on this section is over widening, so when normal to low flows return, the water in the section becomes shallow as the water spreads itself across the now widened area. Of course, now with global warming and extended periods of dry and hot weather, the water temperature can increase in shallow sections of the stream. The picture below shows the widened area of bank erosion, at the time of the picture taken in January this year, there was a snow melt on and the Fourdon burn was carrying a lot of water. This section has already lost at least 4ft of embankment, and the fence line you can see in the picture, will collapse into the stream in the very near future.

I would like to propose carrying out a Willow bank repair at this site, before the erosion gets any worse and to prevent further widening at this spawning area. There are many benefits from undertaking this restoration technique which include, improving water quality by reducing further erosion, reducing impacts on spawning gravel and invertebrates downstream and create habitat refuges for juvenile and adult fish. It also creates shade once the live willow grows in height to help reduce water temperature.

River Tributary	Grid Reference	Activity	Time scale	Description of activity
Fourdon burn length 19 Meters	NJ 73460/36753	Willow bank repair	7 days	Harvest materials 2 days. drive in 57 live Willow posts. Using willow canes weave around posts creating a fence, bank fill with woody brash material from site if possible.
